Refurbishment, Improvements

Repairs & Redecorations

Retro-fitting cavity wall ties

Resin Repair of Masonry Cracks

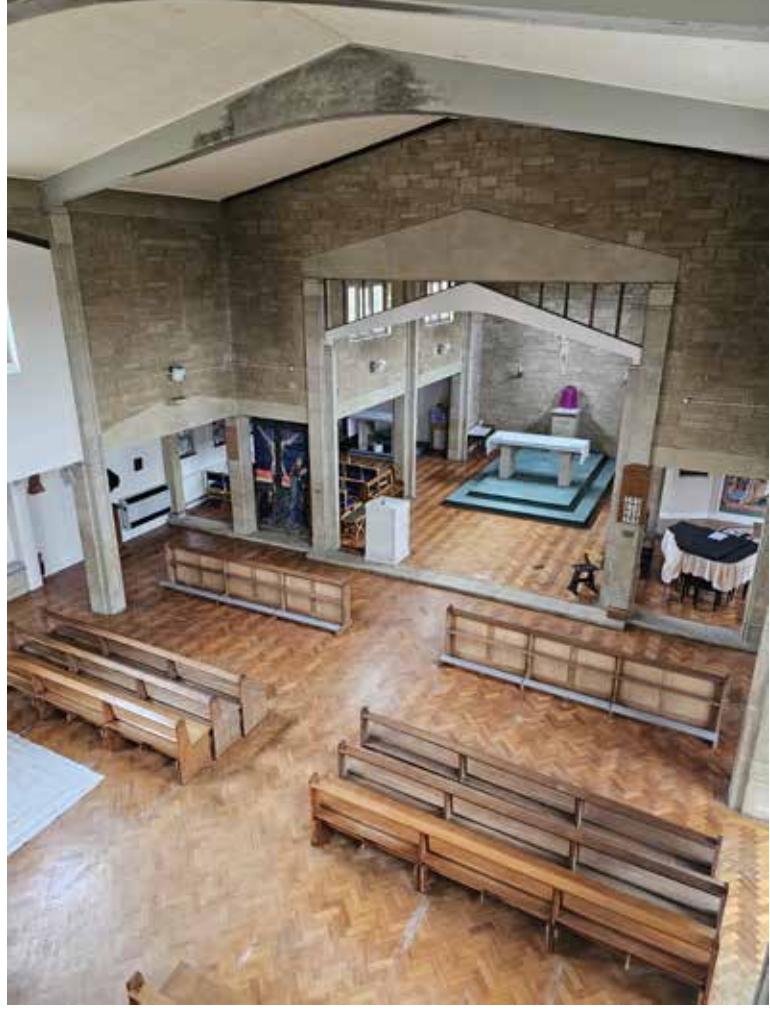
Interior view before renovation.

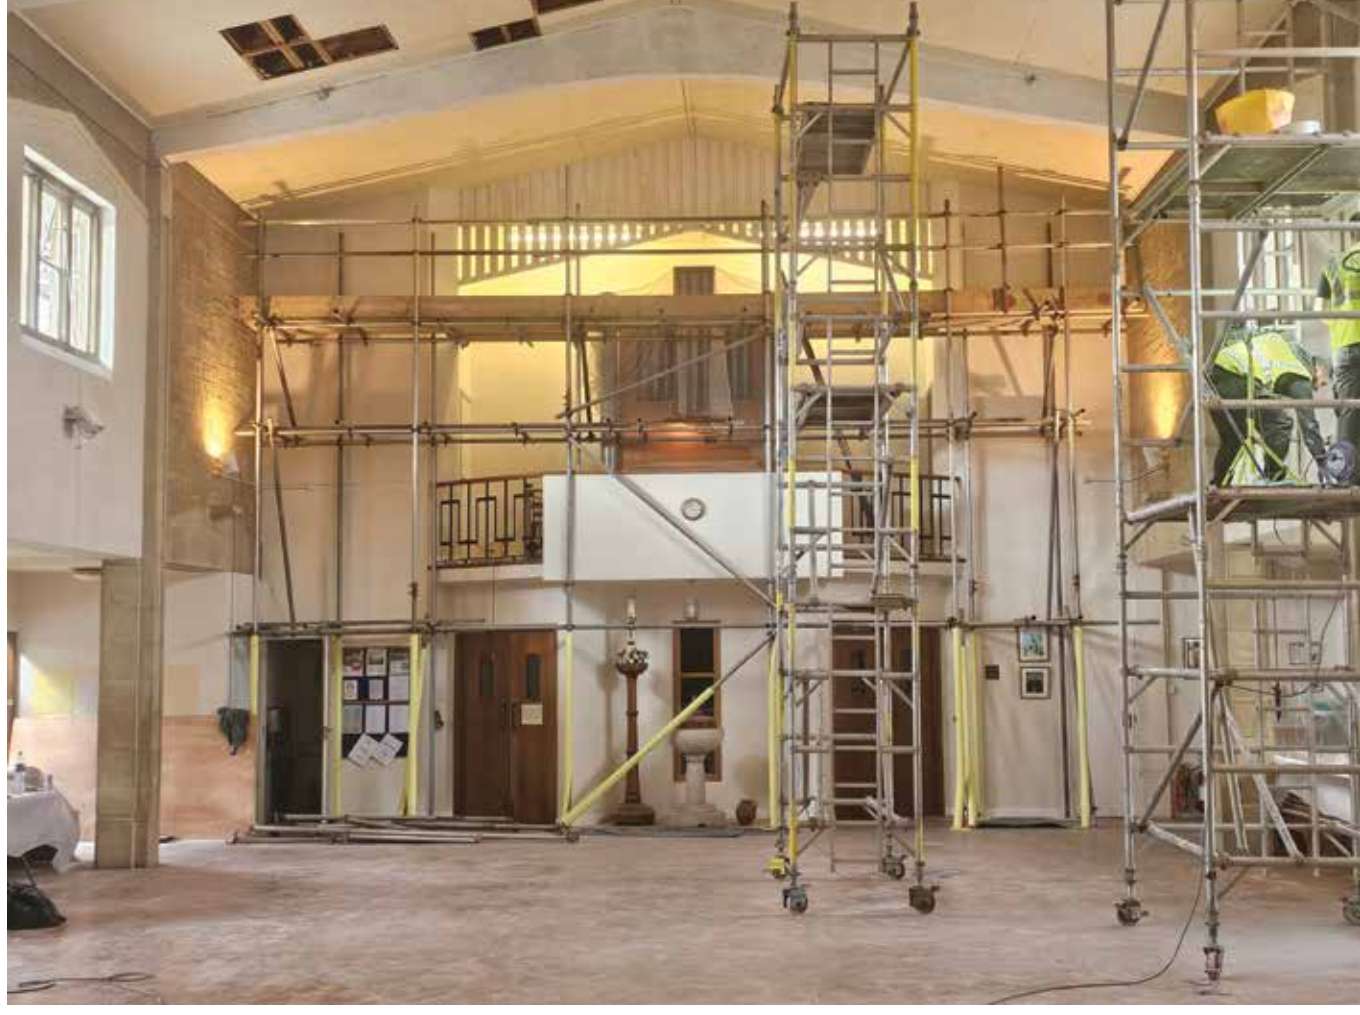
Interior view of the front of the church during redecoration.

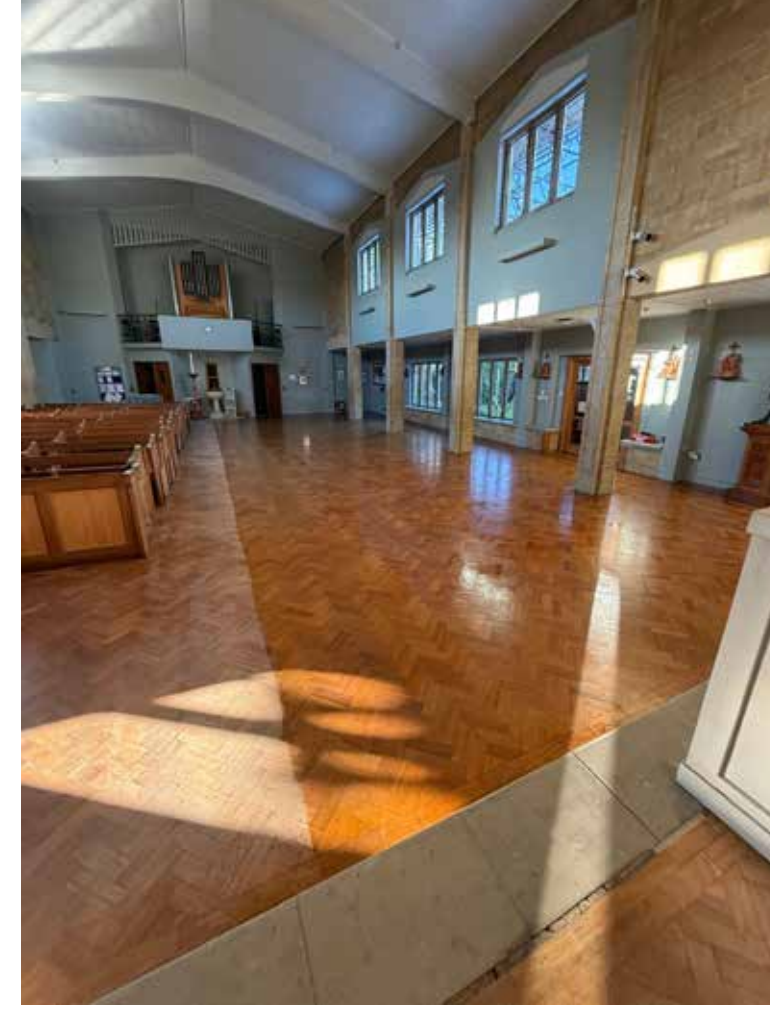
Parquet flooring during renovation.

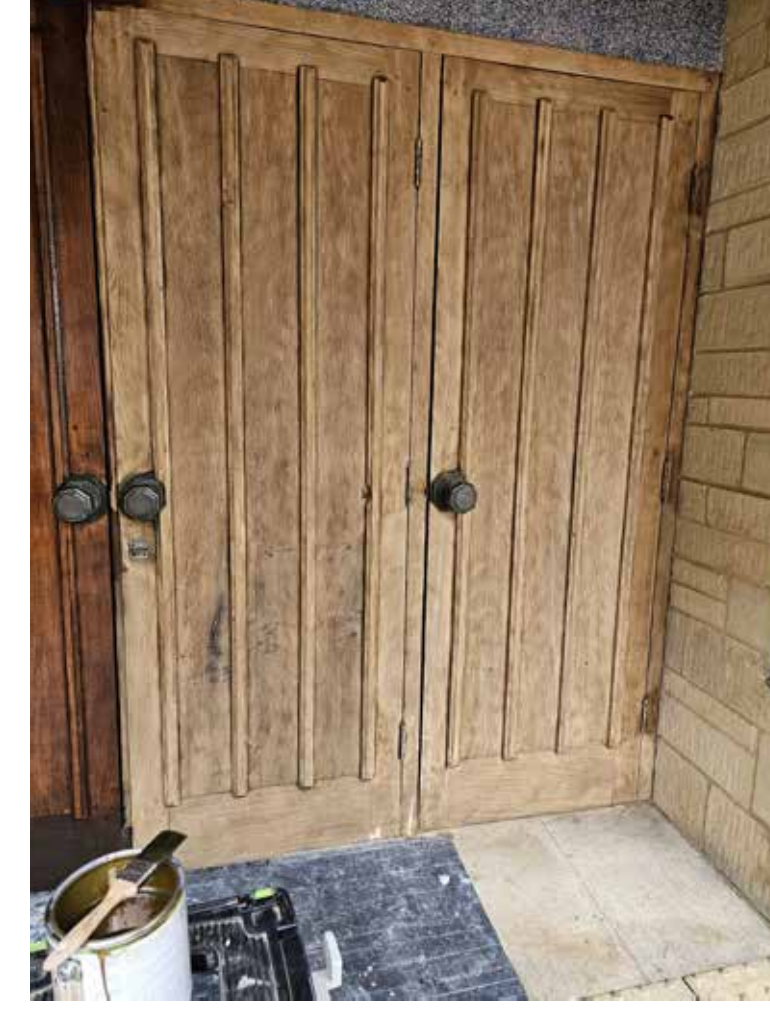
Entrance doors after sanding.

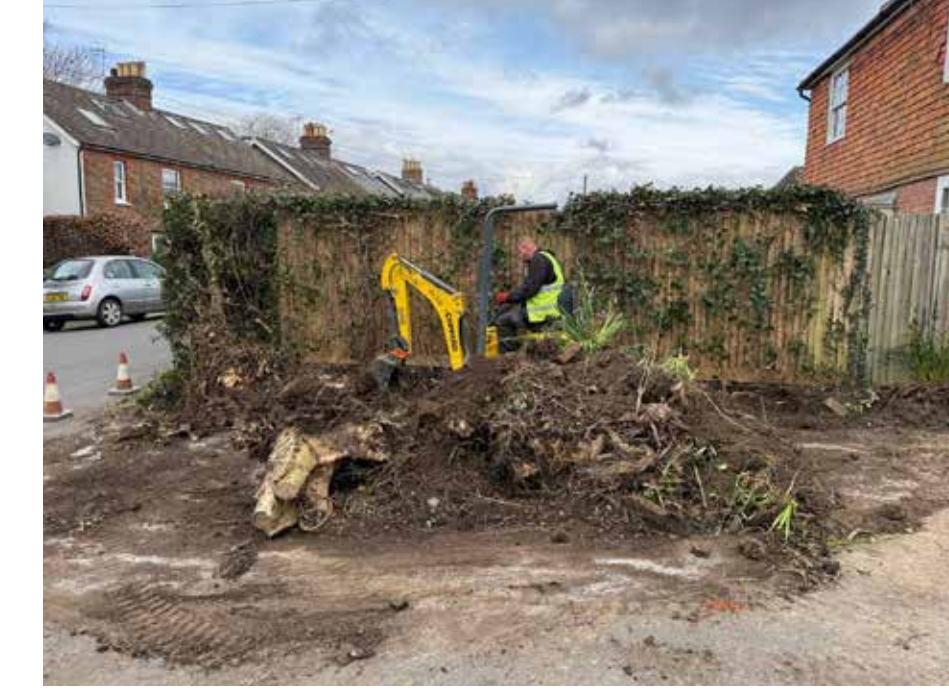
Hedge removed for additional space.

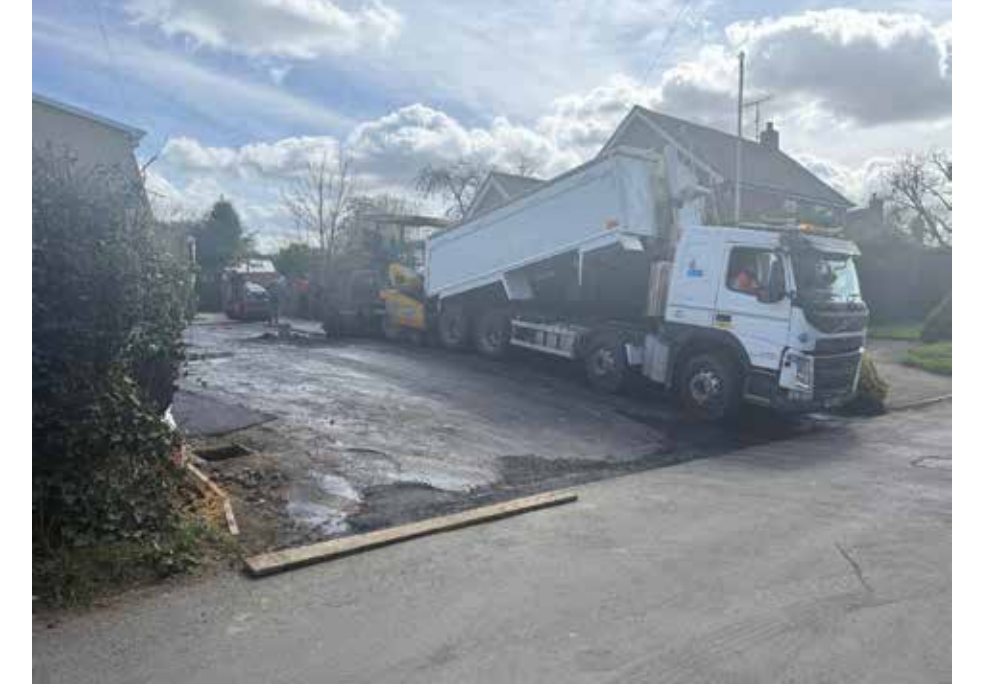
New tarmac surfacing being installed.

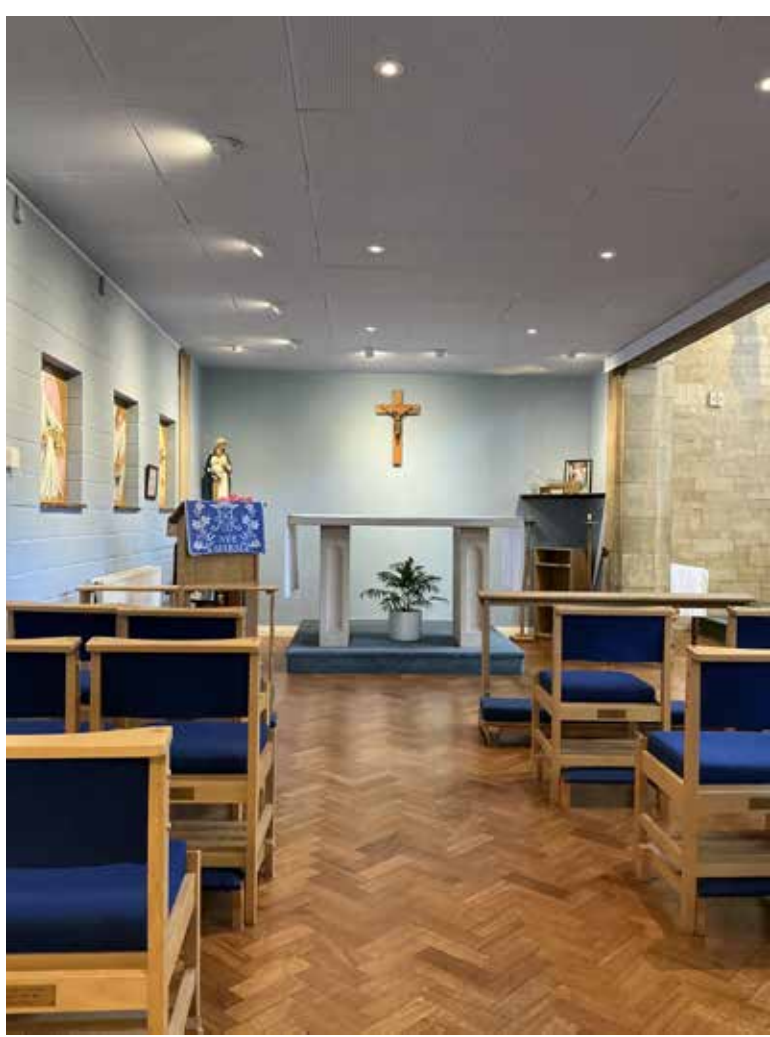
Our Lady Altar after redecoration.

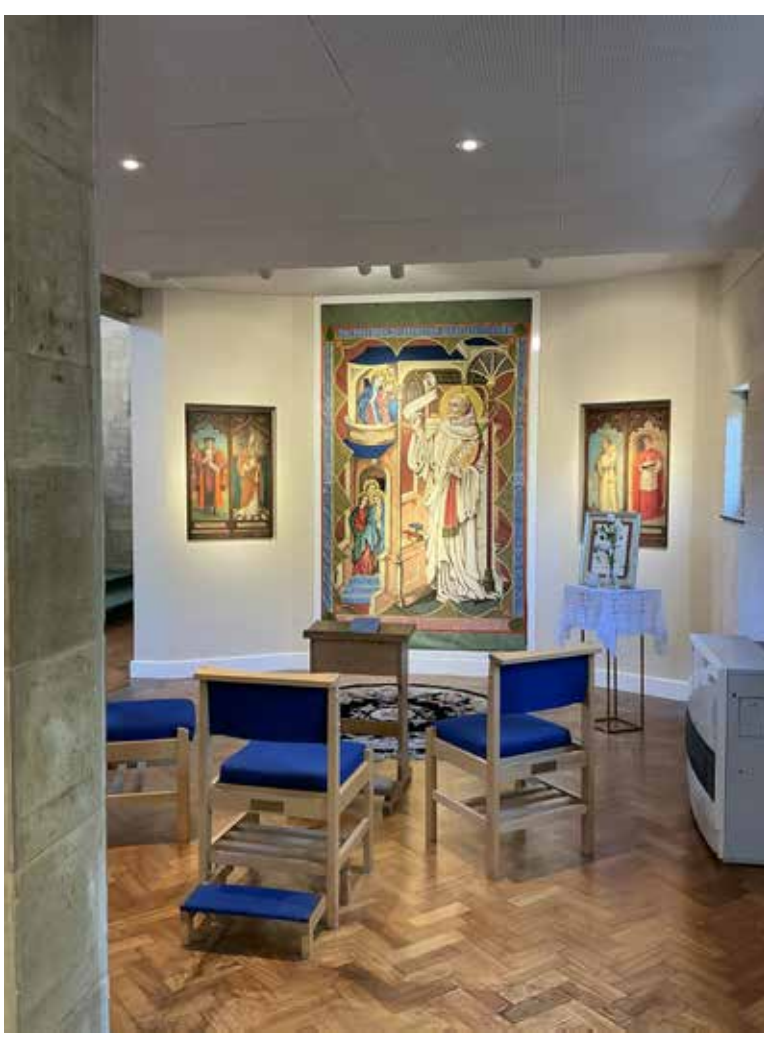
St. Bernard Chapel after works.

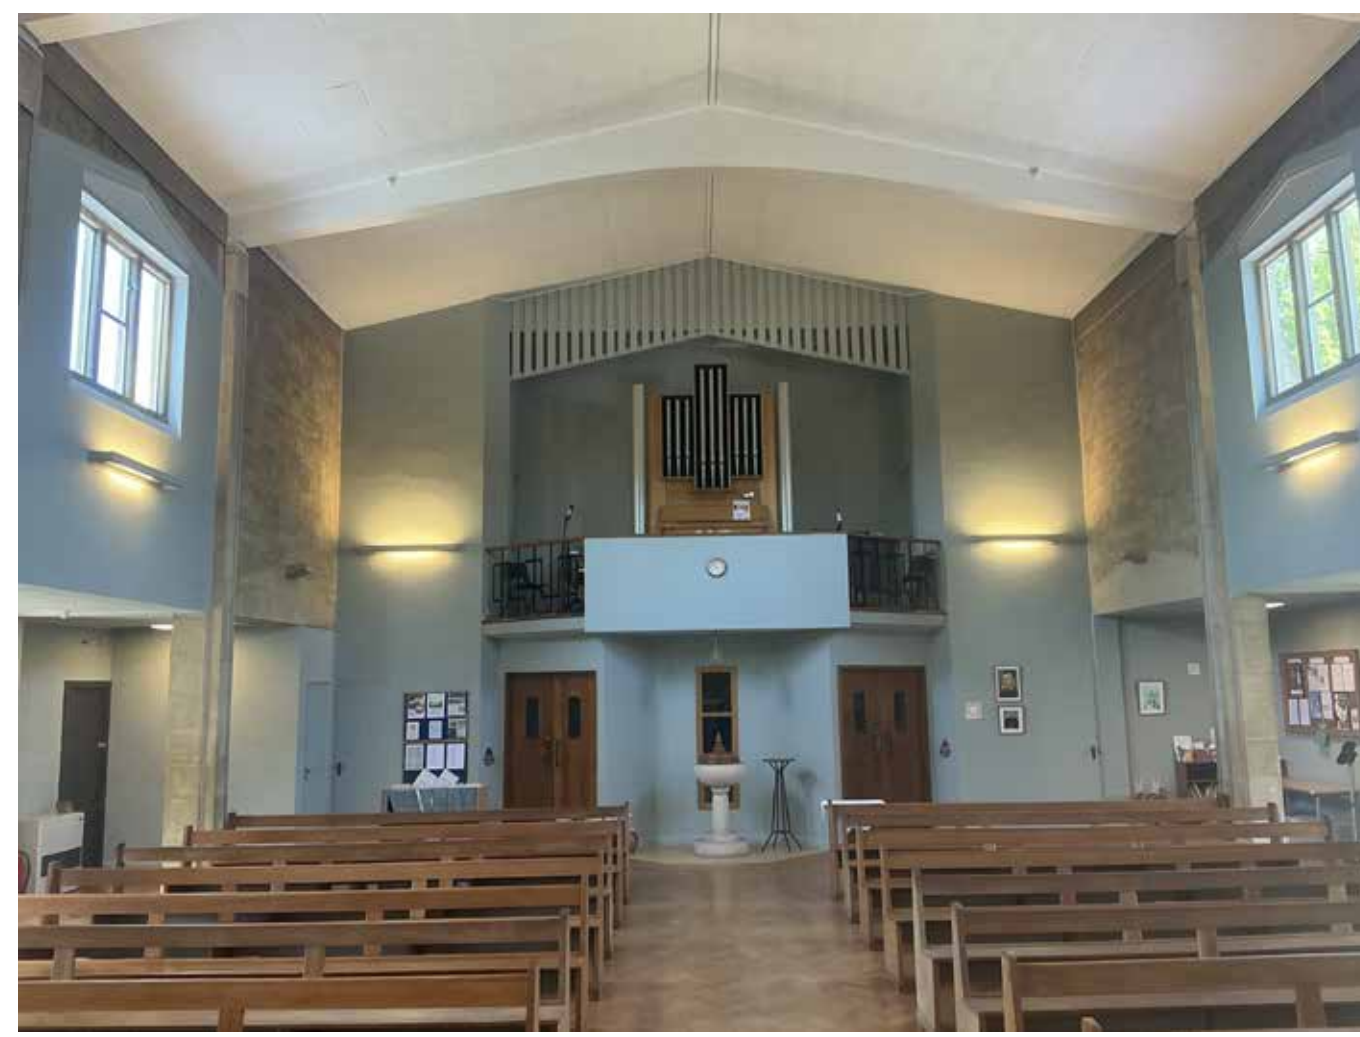
Interior view of the front of the church after redecoration.

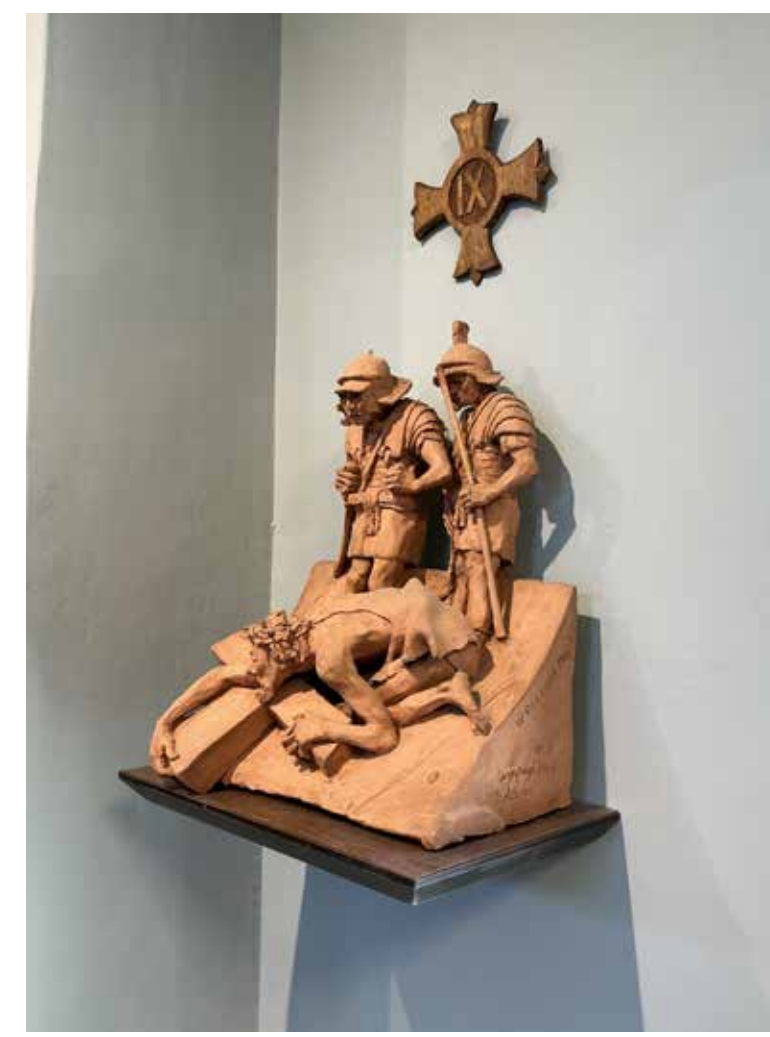
Clay statue mounted on new plinth.

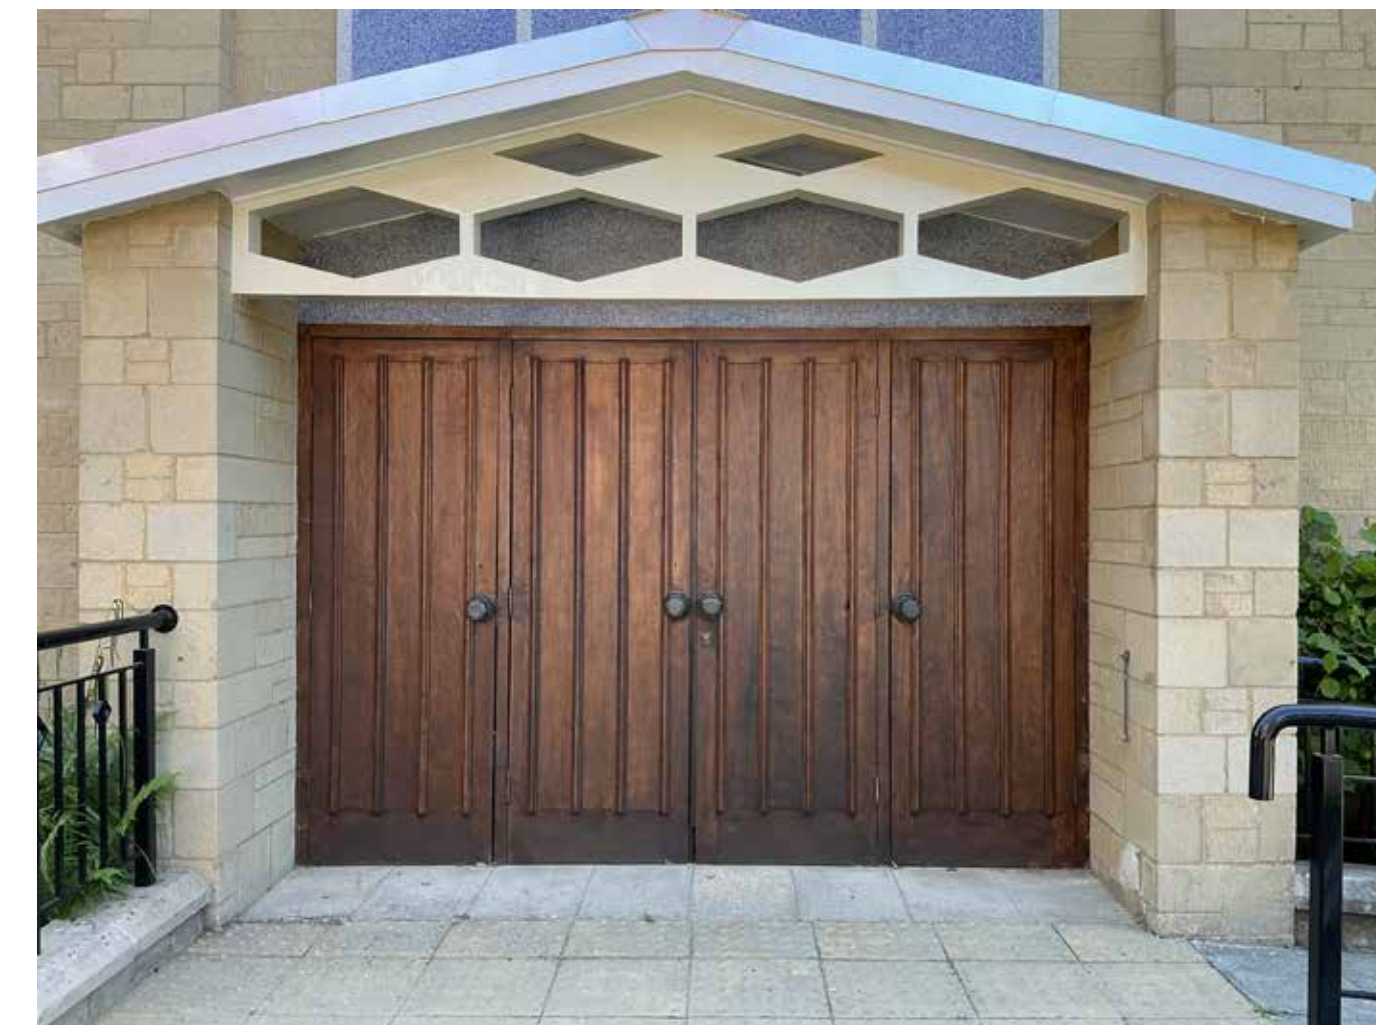
Finished entrance doors after repair, sanding, and staining.

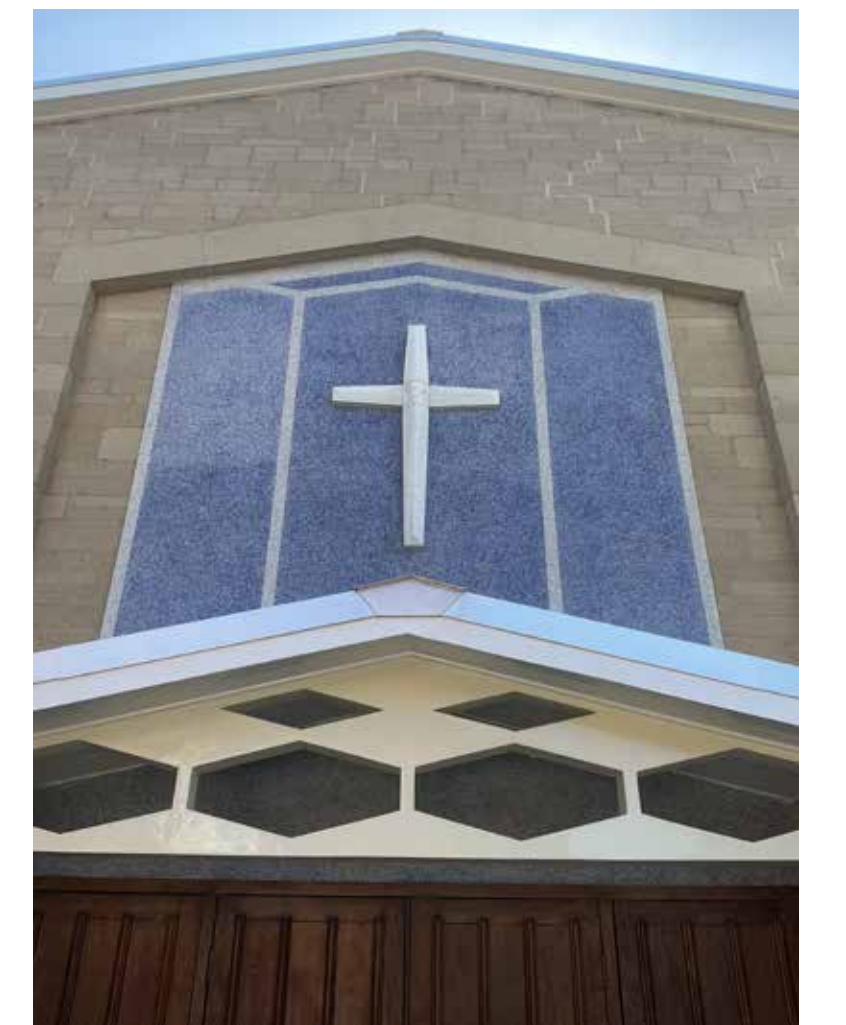
Glass mural & cross after cleaning.

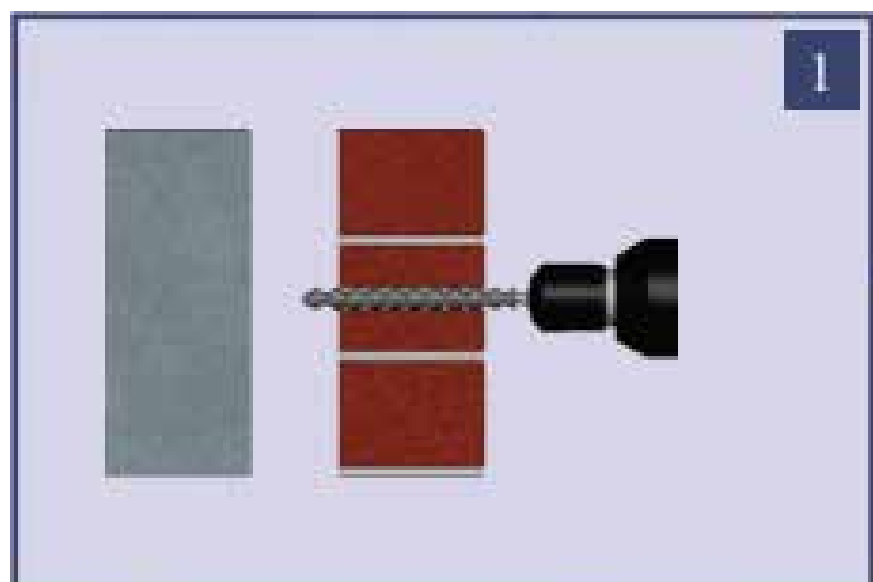
1. Drill a 10mm or 12mm hole through the near leaf using a SDS-plus hammer drill.

The hole should be 25mm from the end of a brick on its horizontal centre line.

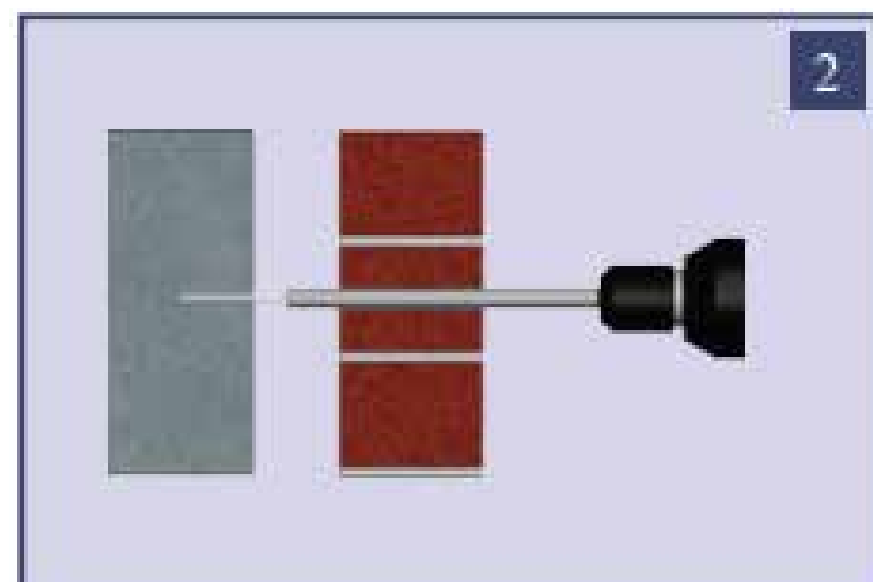
2. Push the Pilot Drill and Drill Extension through the previously drilled hole and drill a pilot hole into the far leaf.

Note: If the far leaf is a soft material, this procedure may be omitted.

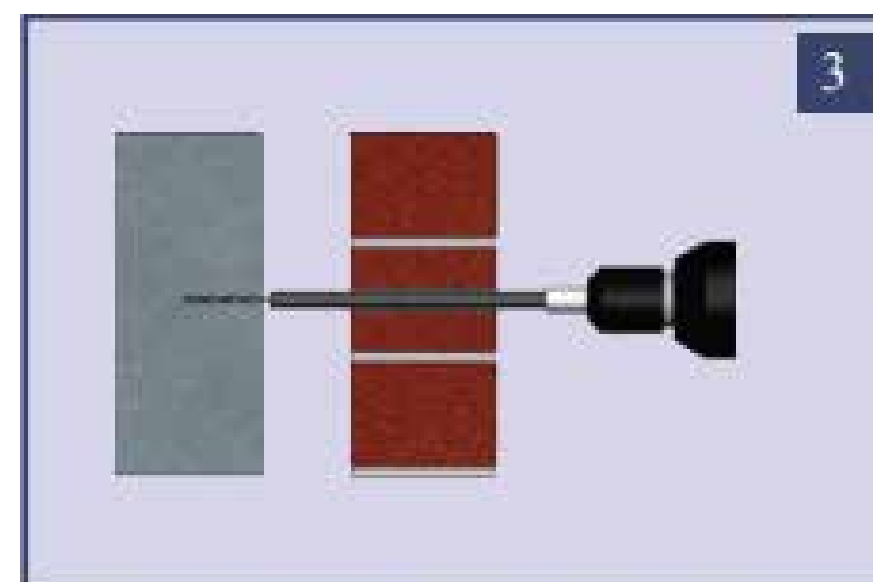
3. Insert the Retro Flex tie into the hole in the near leaf and, using a SDS-plus hammer drill, drive the Retro Flex tie into the pilot hole in the far leaf.

Insert the combination through the hole in the near leaf and, using a SDS-plus hammer drill, drive the Retro Flex tie into the pilot hole in the far leaf.

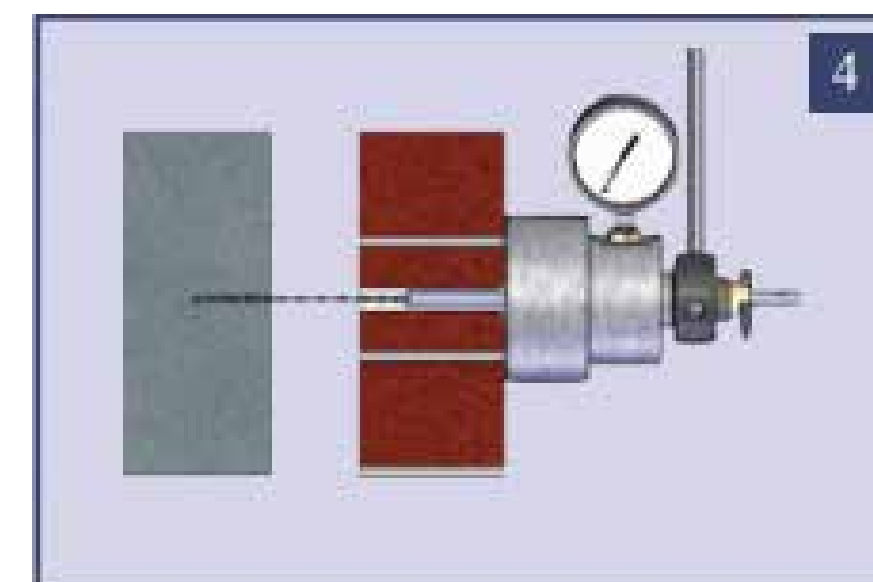
4. Once the Retro Flex tie is installed into the far leaf pilot hole, the holding capability can be checked using a Target Load Test Unit.

As a general rule, about 1kN loading in tension is an adequate bond.

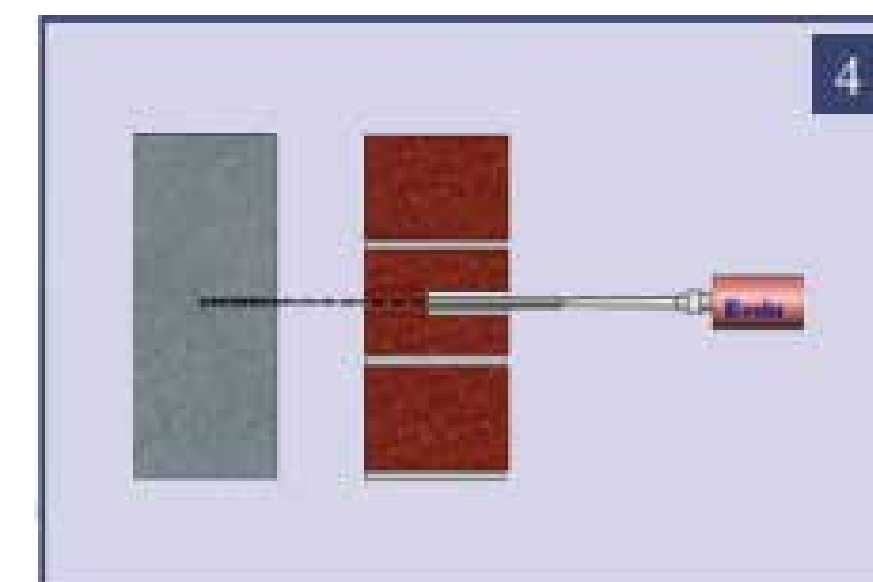
5. After an acceptable proof test is performed, the near leaf connection is made using Target Polyester Resin or Bond Flex XL Cementitious Grout.

The drilled hole may then be colour matched for an excellent finish.

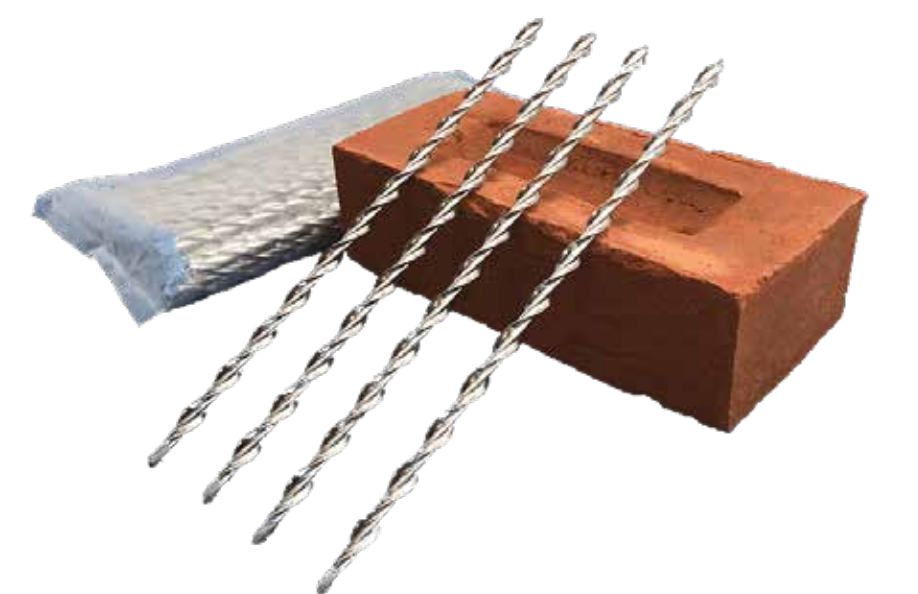
Retro Flex Wall Tie System

The Retro Flex system of wall tie replacement is available in three different diameters - 6mm, 8mm & 10mm.

It offers the advantages of a non-expanding mechanical fixing on the far leaf and a polyester resin or cementitious grout on the near leaf.

Because the fixing method employed does not induce additional stresses into the substrate, Retro Flex can be used in many and varied materials, from poured concrete columns to Aircrete blocks, with satisfactory results and there is no concern to achieve the vital edge distance spacing necessary with any expansion fixing.

These wall ties are attached to this board.

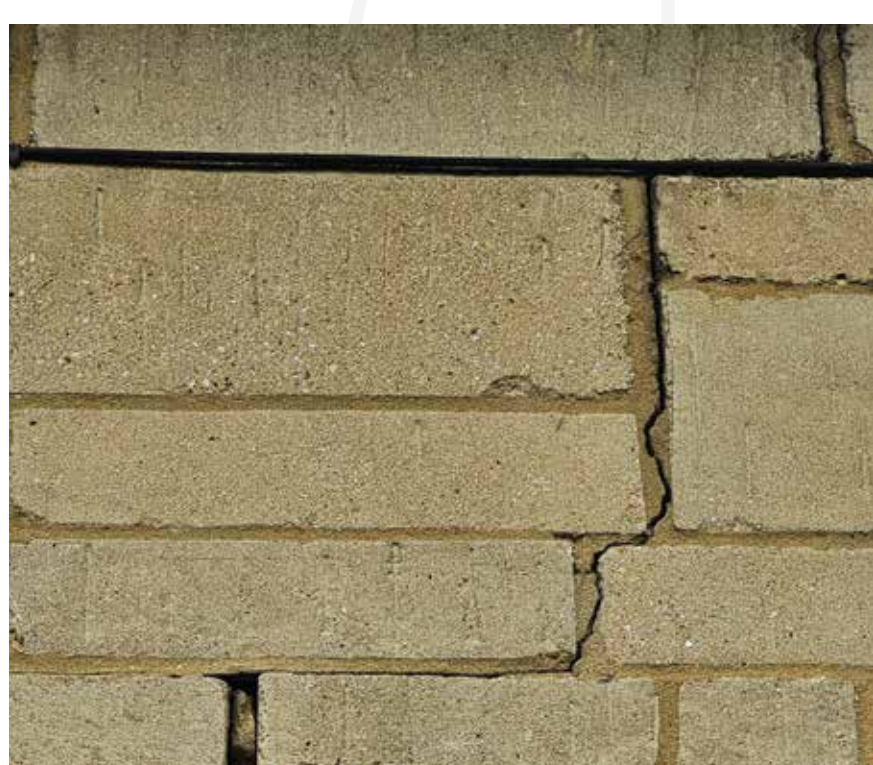
Extensive cracks to masonry evident.

Succeeding the extensive retro-fitting of cavity wall ties, it was necessary to resin repair the various cracking present within both the internal and external leaves - restoring the structural integrity of the walls and preventing any future deterioration.

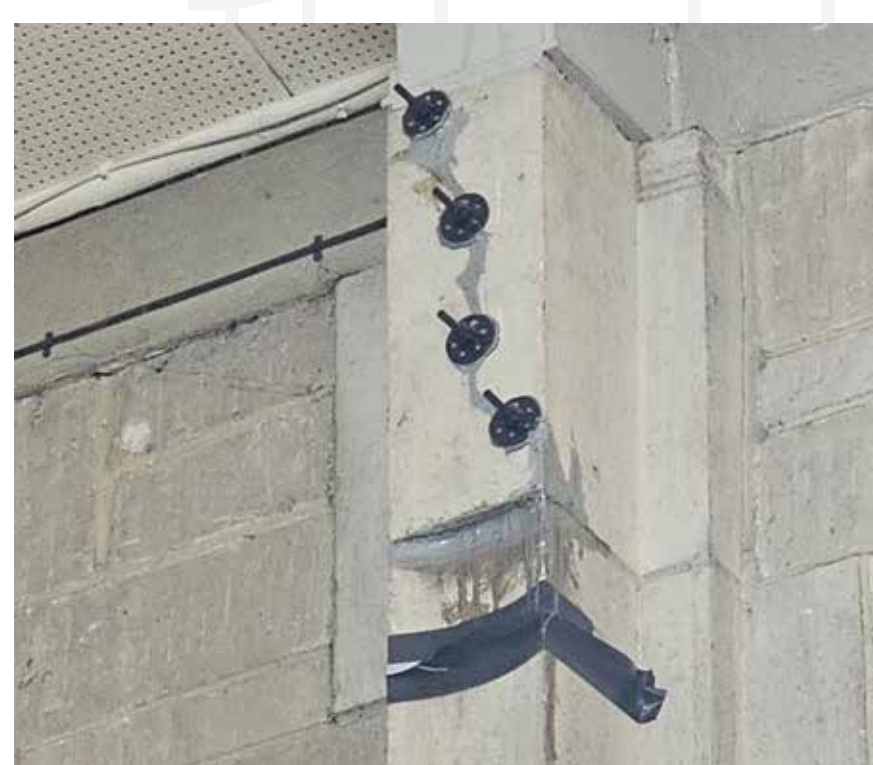
Resin injection of cracks to column.

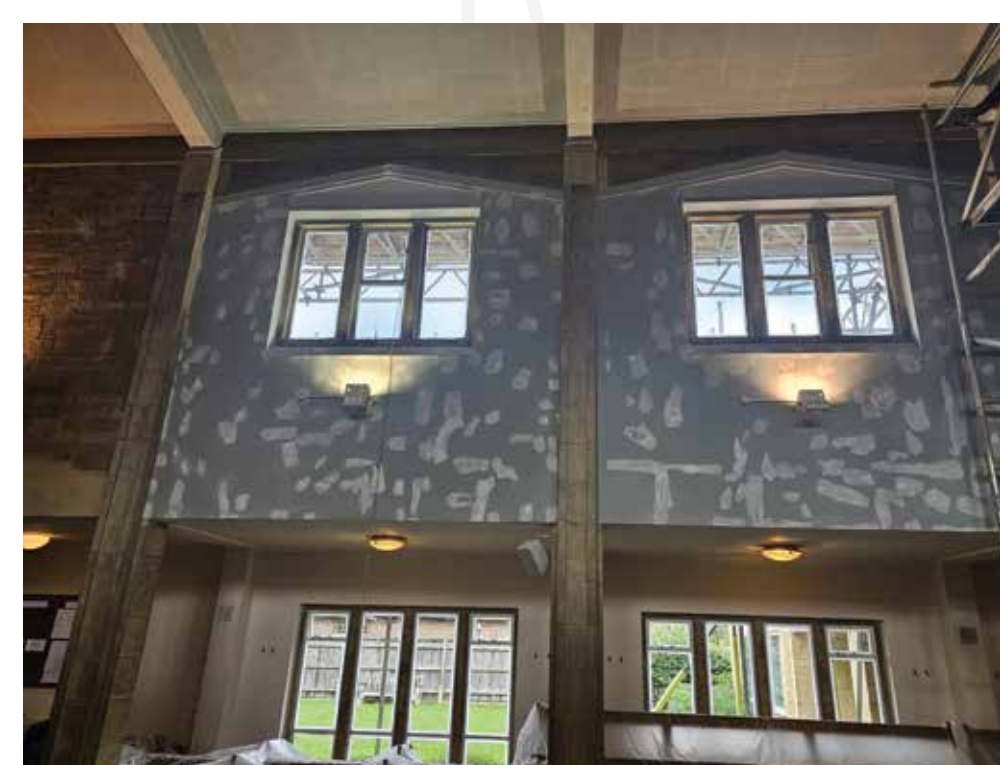
Condition of external walls after injection.

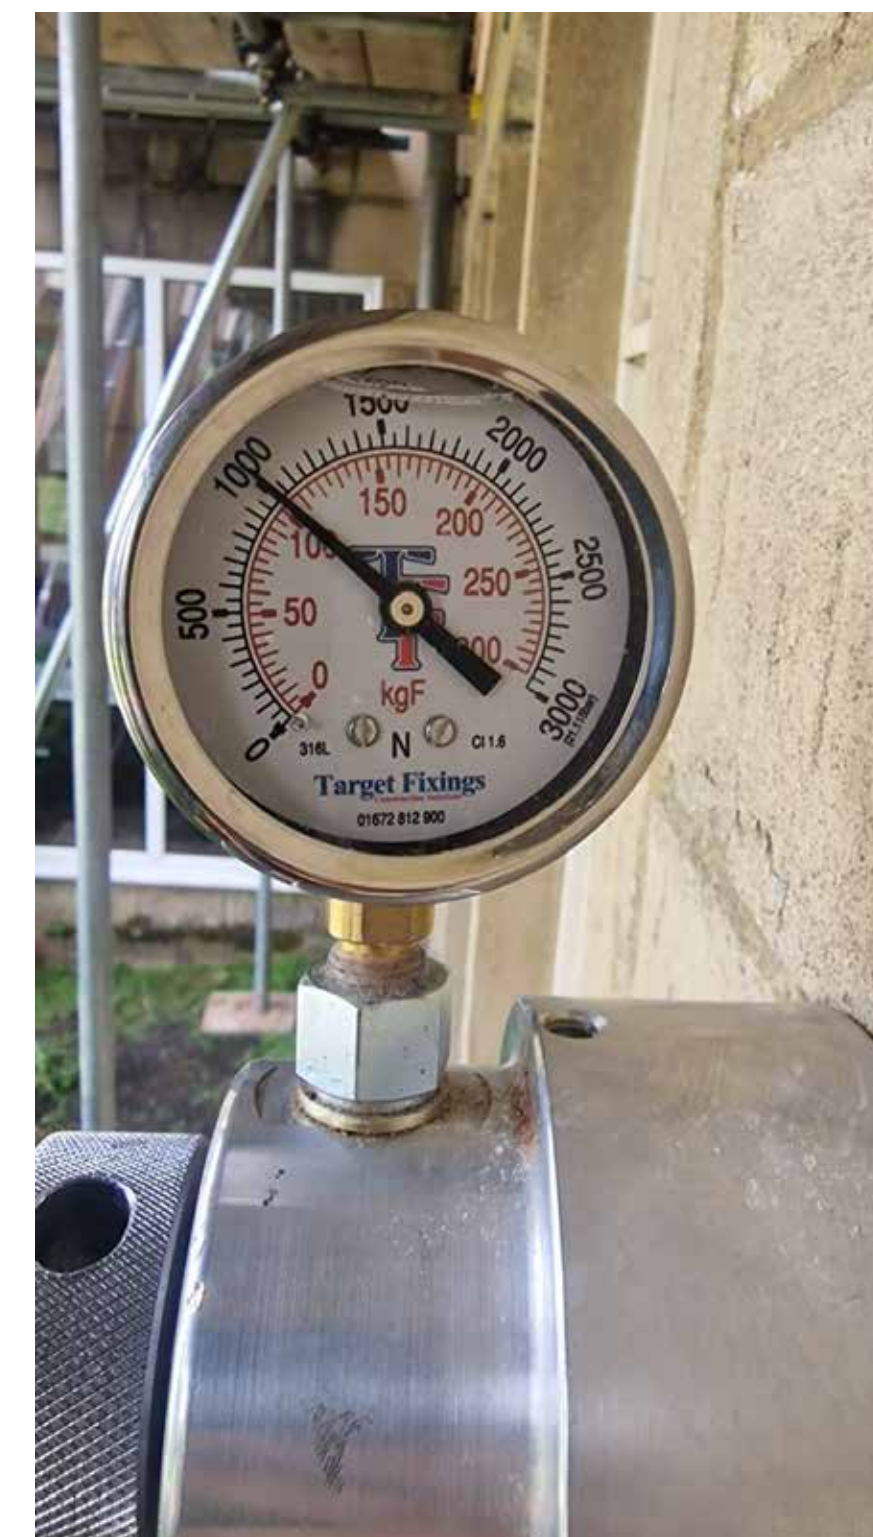
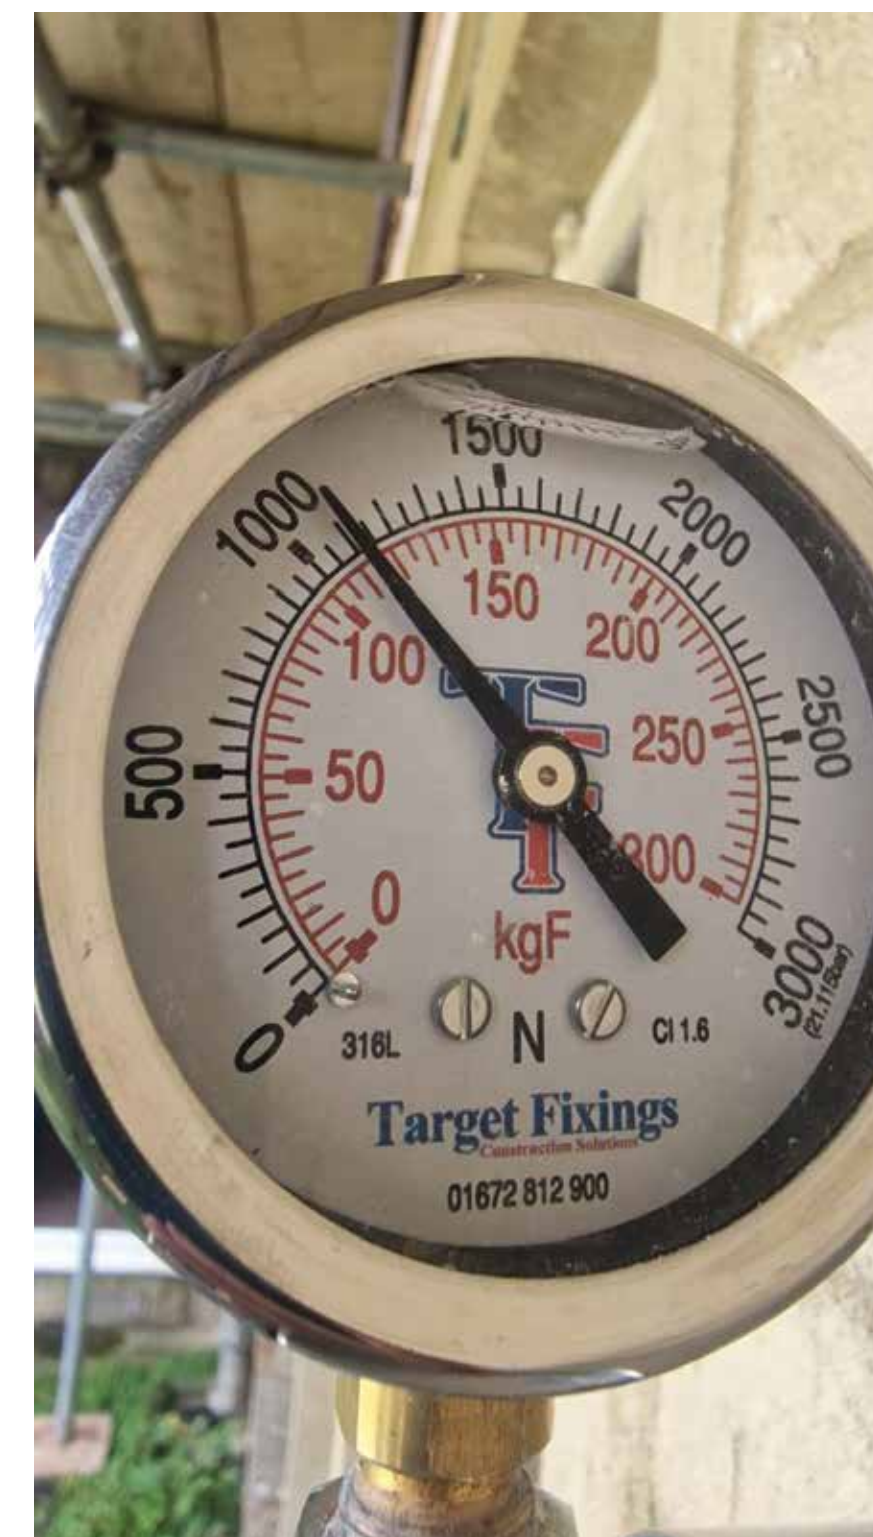
Holding capability of randomly selected retrofitted wall ties being tested using a Target Load Test Unit per Step 4.
